## Structural Study and Evaluation of Previous Restoration Work of Mohammad 'Ali Pasha Mosque at the Citadel in Cairo

Dr. Yaser Yehya Amin Abdel-Aty♦

### Abstract

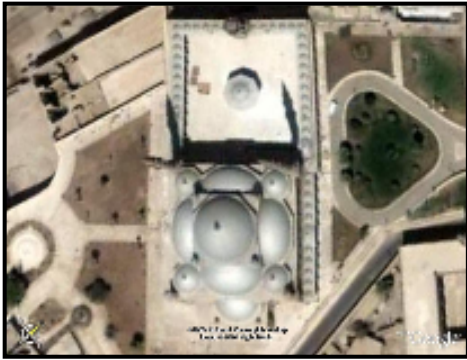
**Plate (2):** Aerial-View of Moh. 'Ali Mosque; shows the compound domed roof  
(After: Google Earth Website).

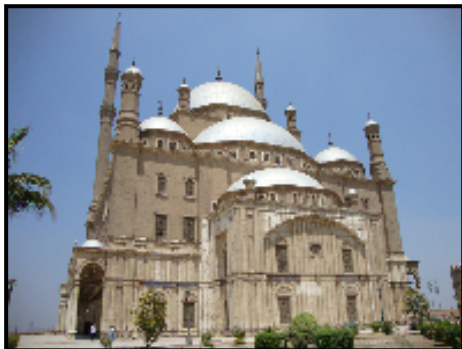
**Plate (4):** S-E Façade of Moh. 'Ali Mosque; shows alabaster cladding and the semi-dome over the mihrab.

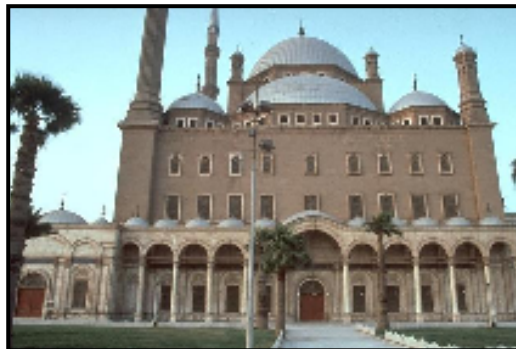
**Plate (5):** N-W Façade of Moh. 'Ali Mosque; shows the external arcade topped by shallow domes and covered with alabaster clad.

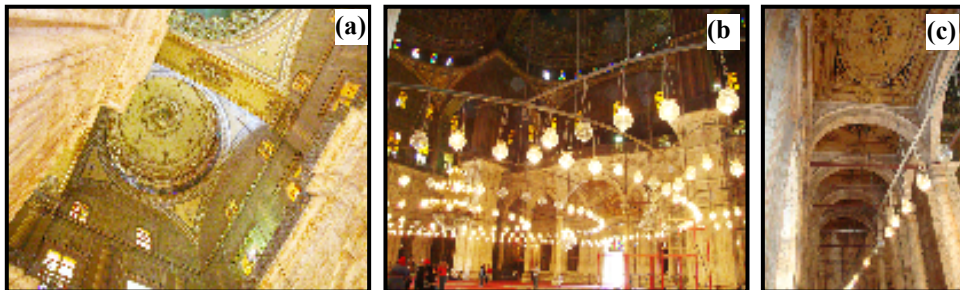
a- Corner (smaller) domes from inside.

b- Balcony (Dikka) over N-W entrance.

**Plates (9: a, b and c):** One of the small domes of the mosque from inside and the N-W Iwan inside the mosque; showing the decoration and alabaster cladding.

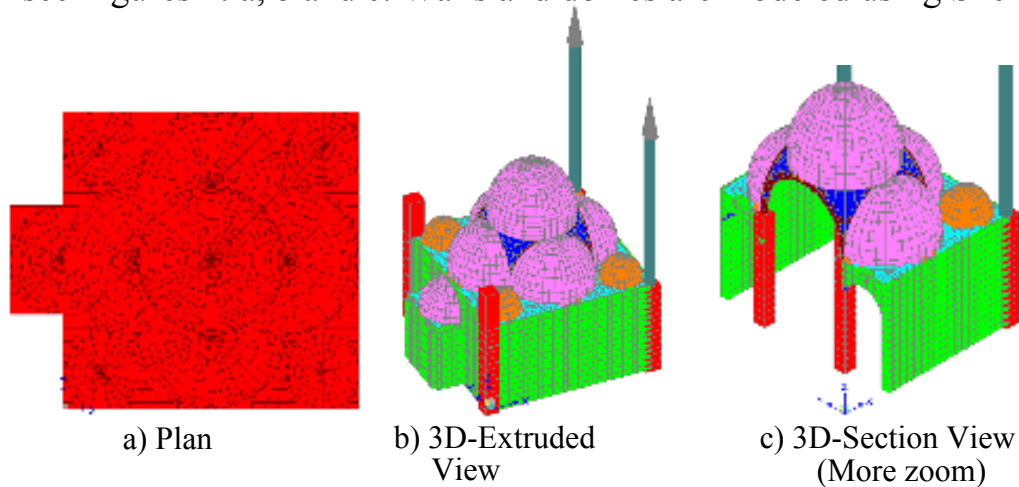
**Figure (4):** Details of the 3D Numerical Model of Moh.'Ali Mosque using F.E.M. (not equal scale). elements, while other structural elements (i.e. columns, arches and minarets) are modeled using 3D-frame-elements.

To understand the structural behavior and determine the failure mechanism of Moh.'Ali Mosque; structural analysis of 3D-numerical model of the mosque is conducted under static and dynamic load cases, utilizing Finite Element Method (F.E.M.). The full mosque is modeled in 3D, using one of the well known computer package utilized in the field of structural engineering<sup>(27)</sup>; see Figures 4: a, b and c. Walls and domes are modeled using Shell-

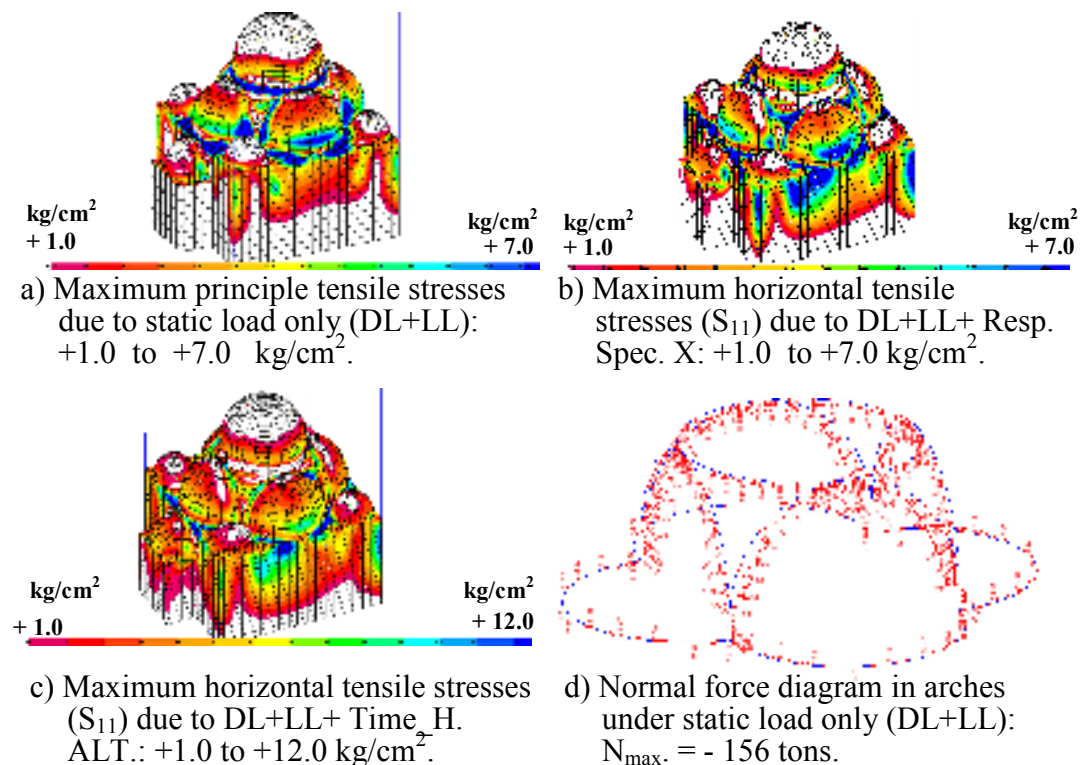
**Figure (7):** Selected results of structural analysis of original condition of the mosque under static and dynamic load cases; showing the most critical **working** stress values.

– Figure (7-a) shows the color code of maximum principle tensile-stress distribution ( $S_{max}$ ) in walls and domed-roof of the mosque; due to static load only (DL+LL). Resulting working stresses range between +1.0 and +7.0 kg/cm<sup>2</sup>, which both are unsafe. The maximum value is 14 times more than allowable flexure tensile stress of masonry ( $f_{tb}$ ). These tensile stresses, under static load only; spread out over the lower half of the main dome, in all area of remaining semi-domes and small domes, and in the upper half of the mosque walls, which are nearly most of mosque elements.

– Figure (7-b) shows distribution of maximum horizontal tensile stresses ( $S_{11}$ ) in the mosque; due to summation of static load-case

– Figure (7-d) shows normal force diagram in main arches and ring beams under static load only (DL+LL). At critical section;  $N = -145$  t. and  $M=42$  m.t. Maximum expected arch cross-section, from similar Islamic mosques in Cairo; is 0.7x1.2 m. Resulting normal stresses range between -7.74 to -42.26 kg/cm<sup>2</sup> (comp.). Maximum stress exceeds allowable values by 2.82 times (282%).

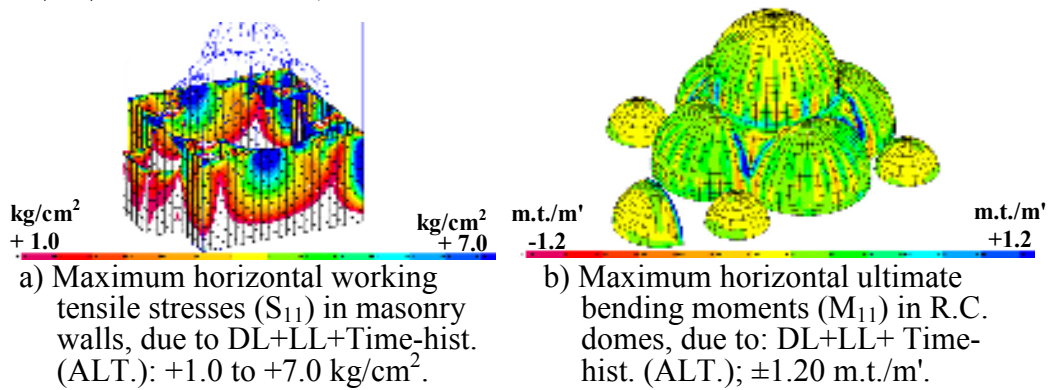
**Figure (10):** Most critical load condition for tensile stresses in masonry walls, and radial bending moments of R.C. domes of the mosque after restoration.

- For R.C. main dome and four semi-domes, the most critical loading condition is the combination of static loads (case-1) with time-history (case-4) of Altadena record. Under this load combination; radial and tangential ultimate bending moments ( $M_u$ ) are less than  $\pm 1.2 \text{ m.t./m'}$ ; see Figure (10-b). Also, the most critical membrane forces ( $N_u$ ) in these domes are the ultimate radial forces ( $F_{11}$ ) that range between  $-28$  (comp.) to  $+26$  (tension) tons/m'. Using ultimate design, chart-D<sup>(55)</sup>, it is found that required radial reinforcement ( $A_{s \text{ req.}}$ ) should not be less than  $7\phi 13/\text{m'}$  for thickness of  $15 \text{ cm}$ ; due to high tensile forces. Tangential reinforcement is the minimum, which is  $5\phi 10/\text{m'}$ . Reinforcement required for the rest of R.C. domes, with  $15 \text{ cm}$  thickness; is  $5\phi 10/\text{m'}$ .
